**Report of
Facility Needs Assessment and
Master Plan**

Garrett County Public Schools

**FEA Project #R01.2013.007735
October 29, 2013**

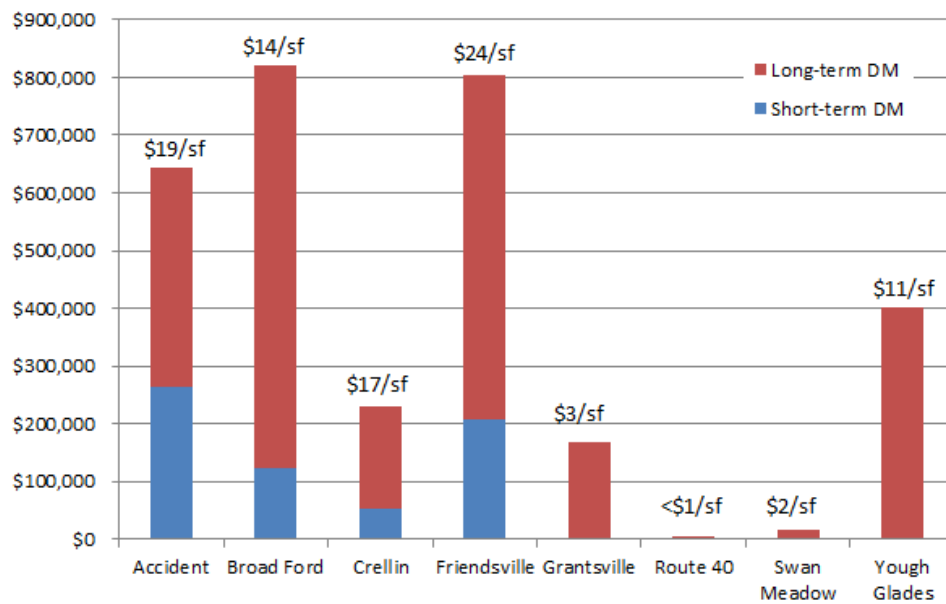
Figure 5 – Summary of Short and Long-term Deferred Maintenance

Figure 5 is a summary of the short-term and long-term DM identified across the schools. When evaluated on a gross square foot basis, the highest cost DM was identified at Friendsville Elementary.

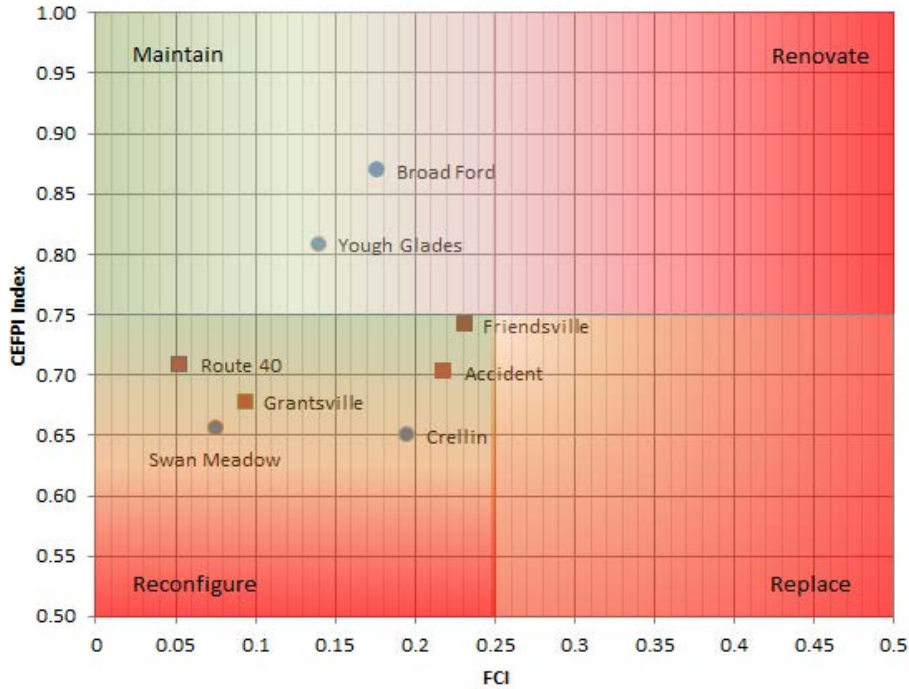
Figure – 6 Summary Plot of CEFPI index and FCI

The results of the suitability assessments are summarized in Figure 6 along with the results of the FCI values from the condition assessment. The CEFPI index is calculated from the individual score sheet total for the school evaluated relative to the total number of points possible if the schools were to meet or exceed the minimum criteria in each category evaluated. Scores below 50% are considered unacceptable and require improvement.

In general, all of the schools scored within an acceptable range. The schools in the northern portion of the County scored within a relatively close range of one another. Broad Ford and Yough Glades scored the highest among all the schools. The scores for Swan Meadow and Crellin were low generally because of the small size and configuration of the facilities. It should be noted, however, that the student clinic arrangement at Broad Ford is unacceptable. There is no dedicated or adjacent restroom facility for students visiting the clinic. The storage space for the clinic is shared with other departments, causing disruptions of service and the potential to transmit conditions to high use areas outside of the clinic. Based on our observations, there did not appear to be a dedicated space for a student clinic at Crellin Elementary.

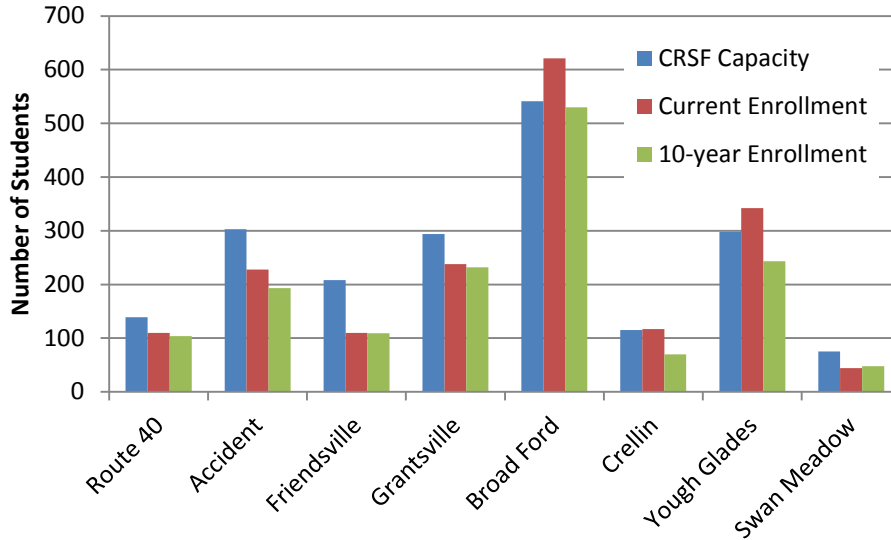
Figure 7 – Summary of Capacity and Current and Projected Enrollment

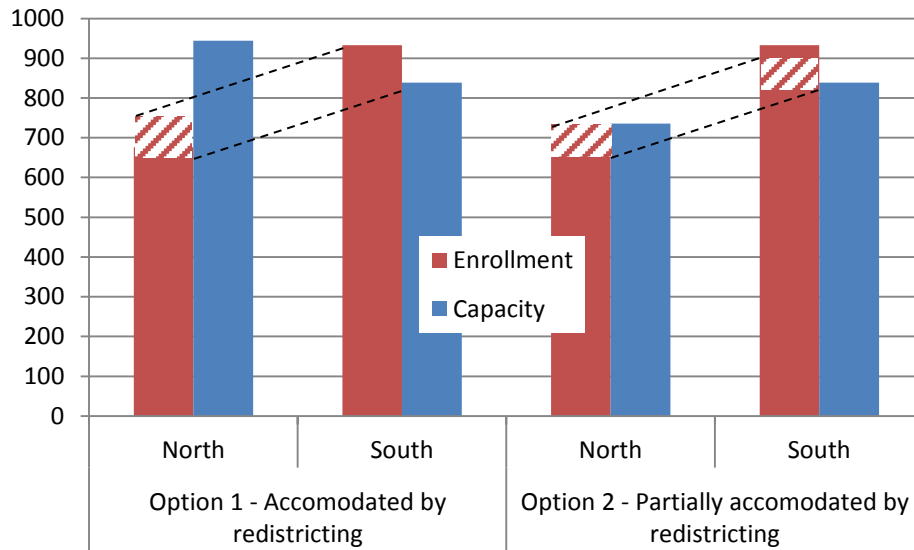
Figure 9 – Accommodation of Overcrowding with Redistricting

\$50,000 to the overall transportation budget. The result is the utilization of Broad Ford and Yough Glades drops to 100% while the combined utilization of the northern elementary schools increases to 82%.

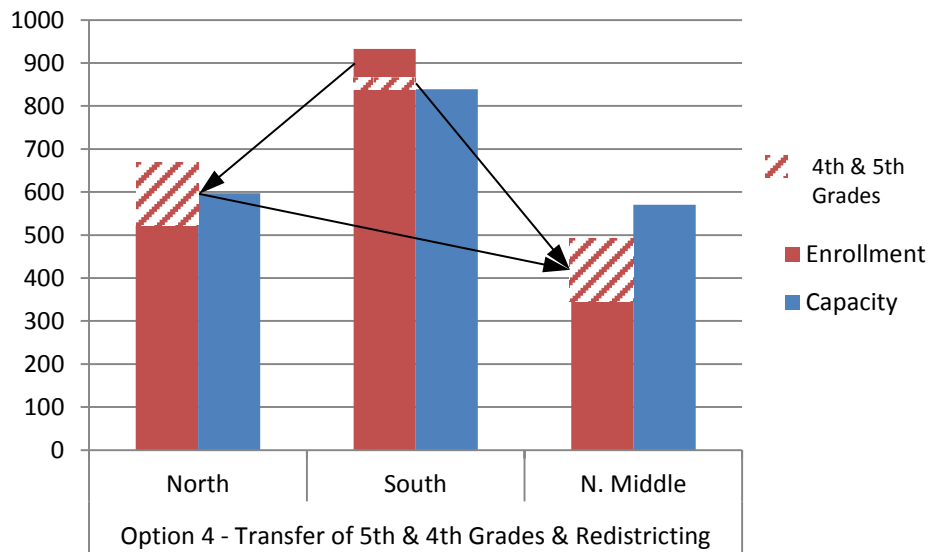
Figure 11 – Reconfiguration of Enrollments in the Northern Schools

schools, intermediate grades 4 through 7 at the middle school, and grades 8 through 12 at the northern high school. In this scenario, Friendsville and Route 40 elementary schools in the north and Crellin elementary school in the south would be closed. The district school boundaries would be revised to redistribute students such that Accident and Grantsville elementary schools would be at or near capacity, the northern middle school utilization would increase to 85%, and the overcrowding at Broad Ford and Yough Glades would be eliminated.

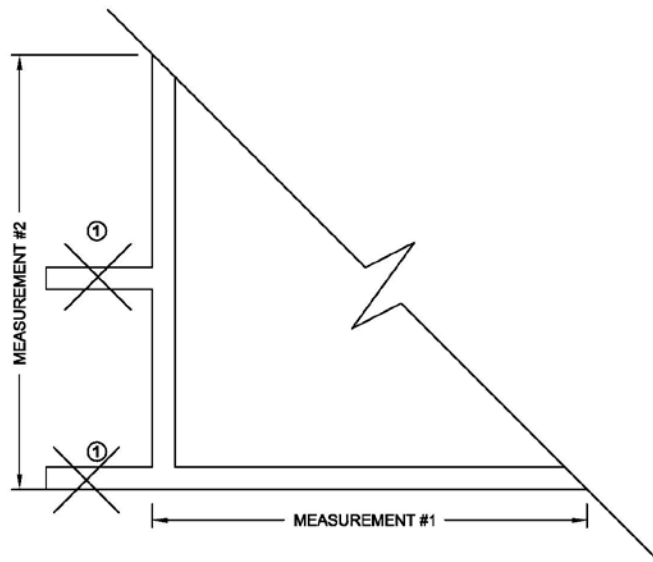
1. Exterior wing walls were not measured or shown on drawings.

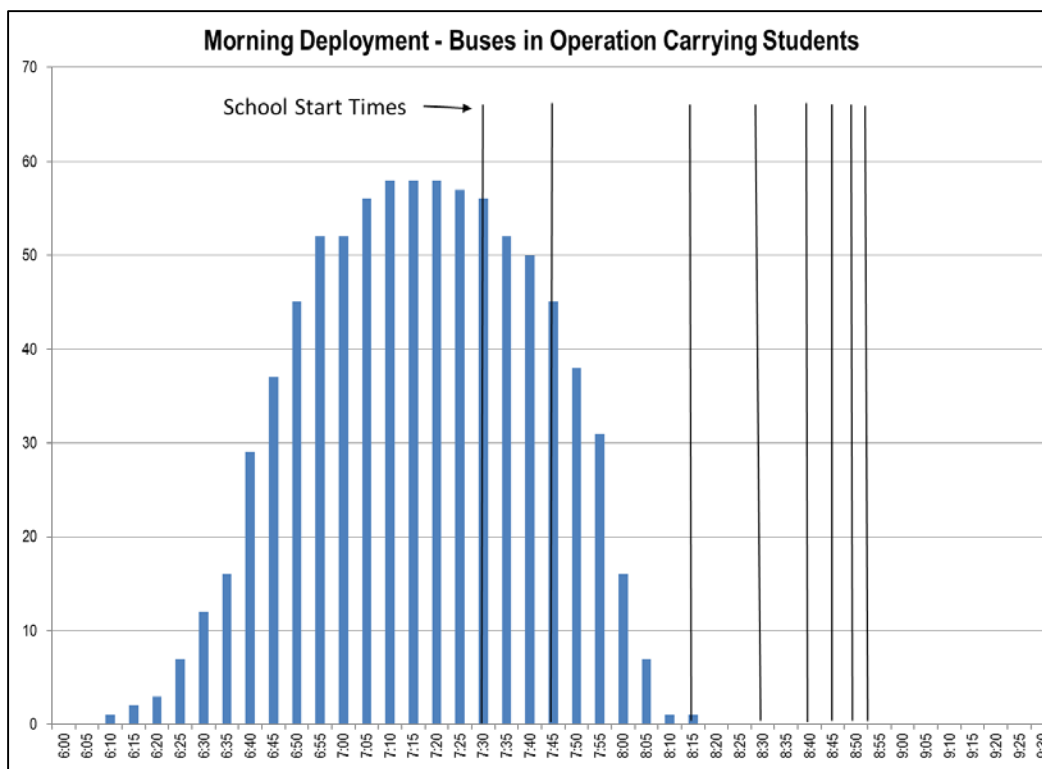
To better appreciate the impact of any school closures or student movements on transportation operations it is also necessary to understand the current deployment of the bus fleet, and the resulting cost effectiveness of the current system. Figure 2 below provides an illustration of the live time (time when students are actually on board the bus) to all schools in the morning panel. The chart demonstrates how, in the morning, the

predominance of all bus routes are both collecting students from multiple schools and arriving at school sites early, in some instances very early. A consideration of the chart indicates to SBC that, based on our experience, because buses are already serving multiple schools the addition of students from the southern portion of the county to the northern portion of the County can generally be accomplished by extending existing bus routes and not by adding new buses. This is an important implication in that the primary cost increases will therefore be incremental “rolling costs” (e.g., fuel, wear and tear on the buses, incremental driver wages) and not the fixed costs associated with the addition of new bus contracts.

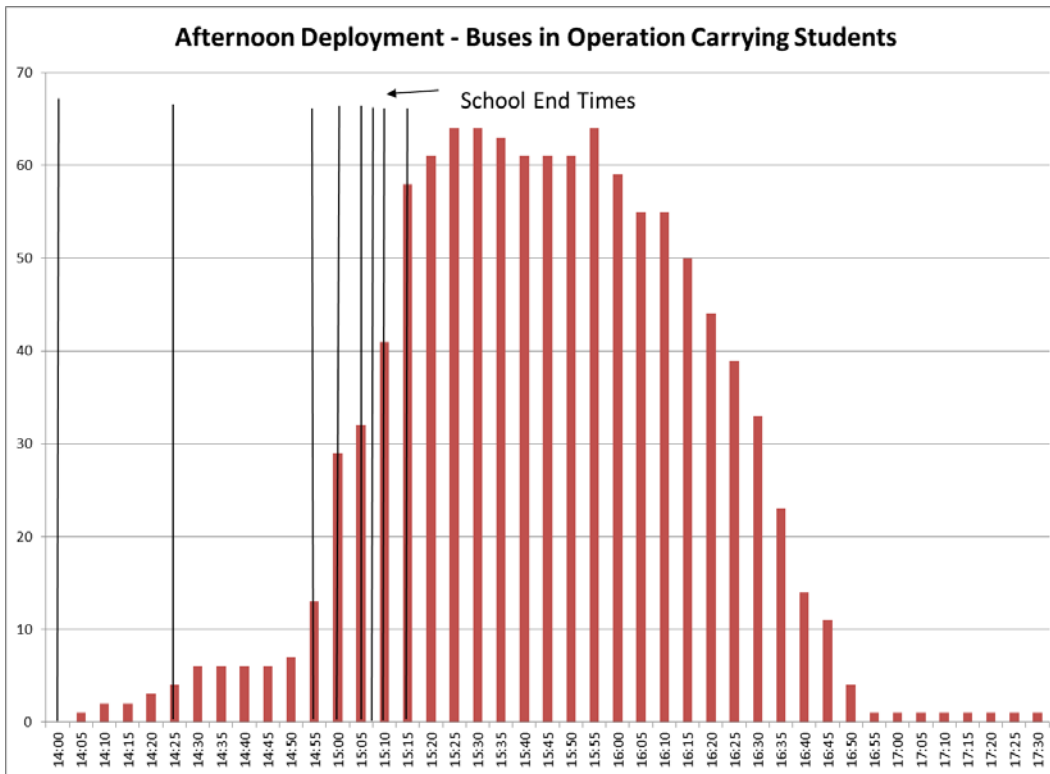
Figure 3

Analysis of the deployment of the fleet in the afternoon provides a similar picture as the morning. However, existing variability in the length of the instructional school day at various schools allows for some routes to be tiered. Instead of combining students from multiple schools on a single bus route, tiering is when a bus collects students from a single school, drops them all off, and then proceeds to another school to collect a second group of students. Here the primary concern is that transferring students from the north to the south or across greater distances east/west in the county will upset this tier balance. The impact of upsetting that balance is unclear without further analysis but may result in the need for additional buses in the afternoon panel, or a decrease in service quality as student wait time at school for buses to arrive is increased.

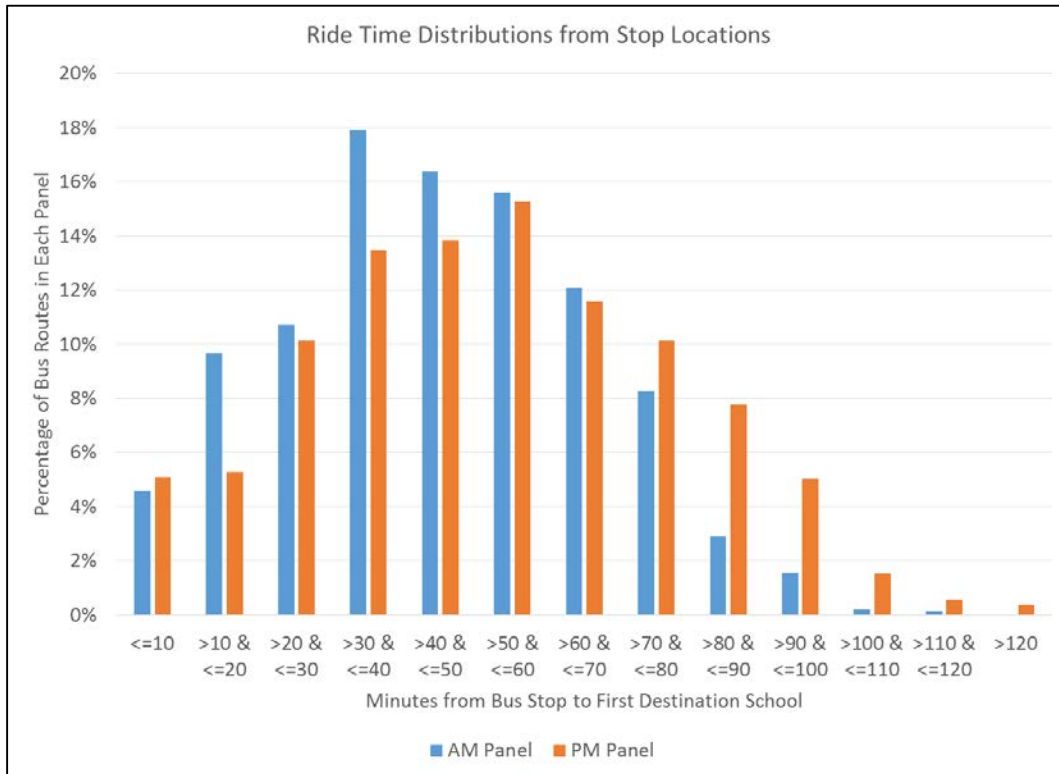
Figure 4 on the following page provides a final view of the current system that is critical to understanding the impact of the scenarios under consideration. The distribution of current bus ride times for students is illustrated in 10 minute increments. These ride times are calculated from current stop locations across the county. Data to calculate actual student ride times was not available for this analysis. The limitation imposed is that the load at each stop is not known. Therefore the actual distribution may be different than displayed here.

Currently, the longest bus route time is over two (2) hours and the average ride time from existing bus stops to the destination school is approximately 39 minutes. It is these values, a primary measure of service quality, against which the four scenarios are assessed. Figure 4 also demonstrates that ride times are generally shorter in the morning than they are in the afternoon.
